MSC APOLLO 13 INVESTIGATION TEAM

SPACECRAFT
INCIDENT INVESTIGATION

VOLUME II

MANUFACTURING AND TEST HISTORY
OF OXYGEN TANK

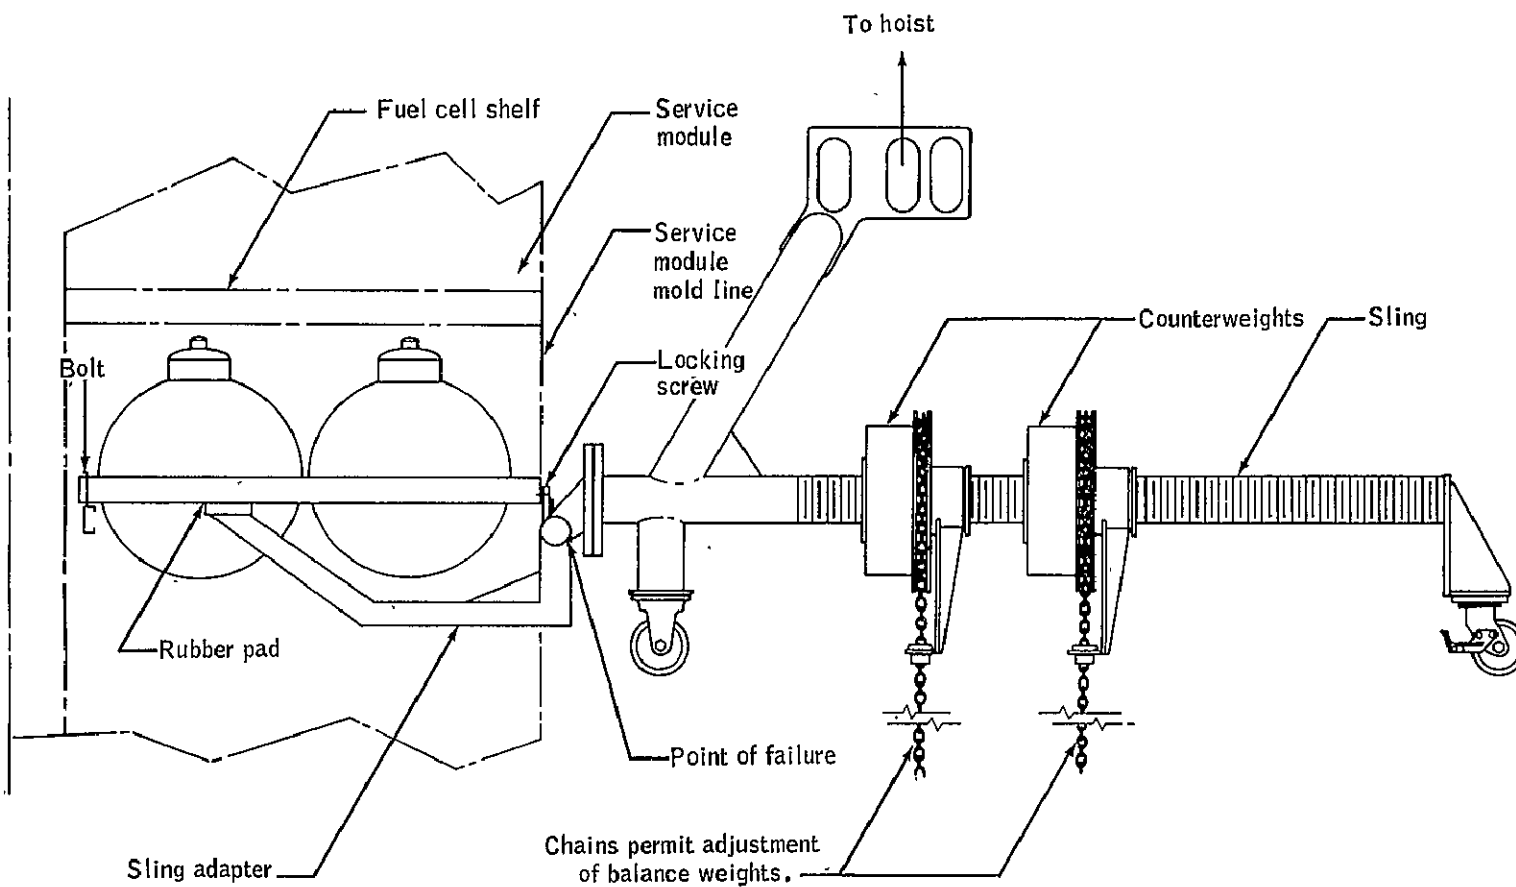
Figure 2-2.- Oxygen shelf and hoist assembly.

According to the technicians and inspectors, all steps had proceeded normally until step 9, when adapter 9EHL009 failed at a weld joint between two 3 inch 1/8 inch wall aluminum tubes (fig. 2-2 point D), allowing the shelf with a portion of the adapter attached, to drop back down onto the service module support angles. The distance of the drop was estimated at the time to be approximately 2 inches.

1. A 10-32 screw attaching tank no. 1 and the shelf assembly to a bracket between radial beams 3 and 4 had not been removed, leading to high moments on the 9EHL009 adapter.
2. The normal periodic proof load was 2 days overdue. This period was extended by NR and NASA QC for the emergency usage on this removal.
3. The normal load and proof load, 200 lb and 300 lb respectively, were low for the actual estimated shelf weight of 247 lbs.
4. The weld joint which failed had poor penetration and a lack of wetting with the cross section less than parent metal thickness in the tension area of the weld.

Photographs of the failed weld do confirm that failure initiated in the weld at the top of the joint; such a failure is consistent with a bending moment which induces tension in the top fiber. An estimate of the strength of the section at the weld, based upon dimensions scaled from the photograph, yielded a minimum failing load of 8500 inch-lbs moment with an upper bound of 16 000 inch-lbs. The minimum value gives a positive margin of 16% (to failure) for the one-g balanced position of the assembly. Investigation of the mass properties of the handling fixture determined that the center of gravity shift was limited to approximately 10 inches (maximum possible counterweight movement).

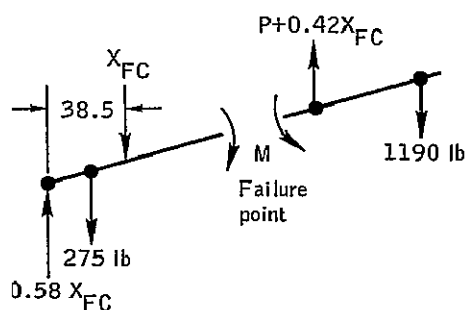
Case 1 - Fuel cell shelf contact

Assume a force, X_{FC} , exerted by fuel cell shelf.

For an $X_{FC} > 406$ lb, the ground support equipment bearing pads swing free: This loading condition reduces the moment at the failure point to 15 percent of its balanced one g value. i.e., $M = 1110$ in-lb.

Conclusion: Sequence excluded

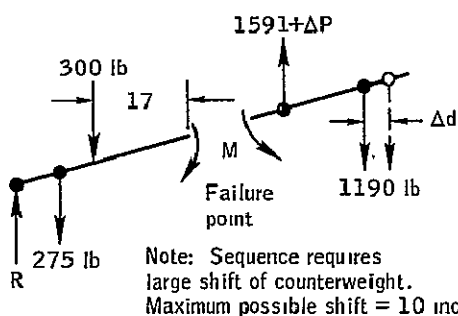
Case 2 - Counter weight shift and shelf contact

Assume shelf contact force to be constant 300 lb and counter weight C.G. adjusted Δd to balance loads. Moment, M , at failure point: $8500 < M < 16,000$ in-lb

Conclusion: Sequence unlikely

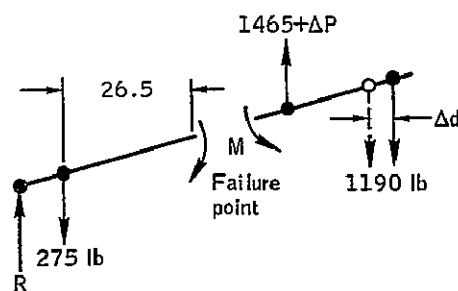
Case 3 - Counter weight shift

Moment, M , at failure point: $8500 < M < 16,000$ in-lb

very large movement of the counterweight center of gravity to produce moments consistent with the failure. For example, a shift of 10 inches in center of gravity requires that the counter weights be moved to the out-board stops; moving one counterweight only to achieve this configuration requires a shift of 29 inches. This sequence is considered unlikely.

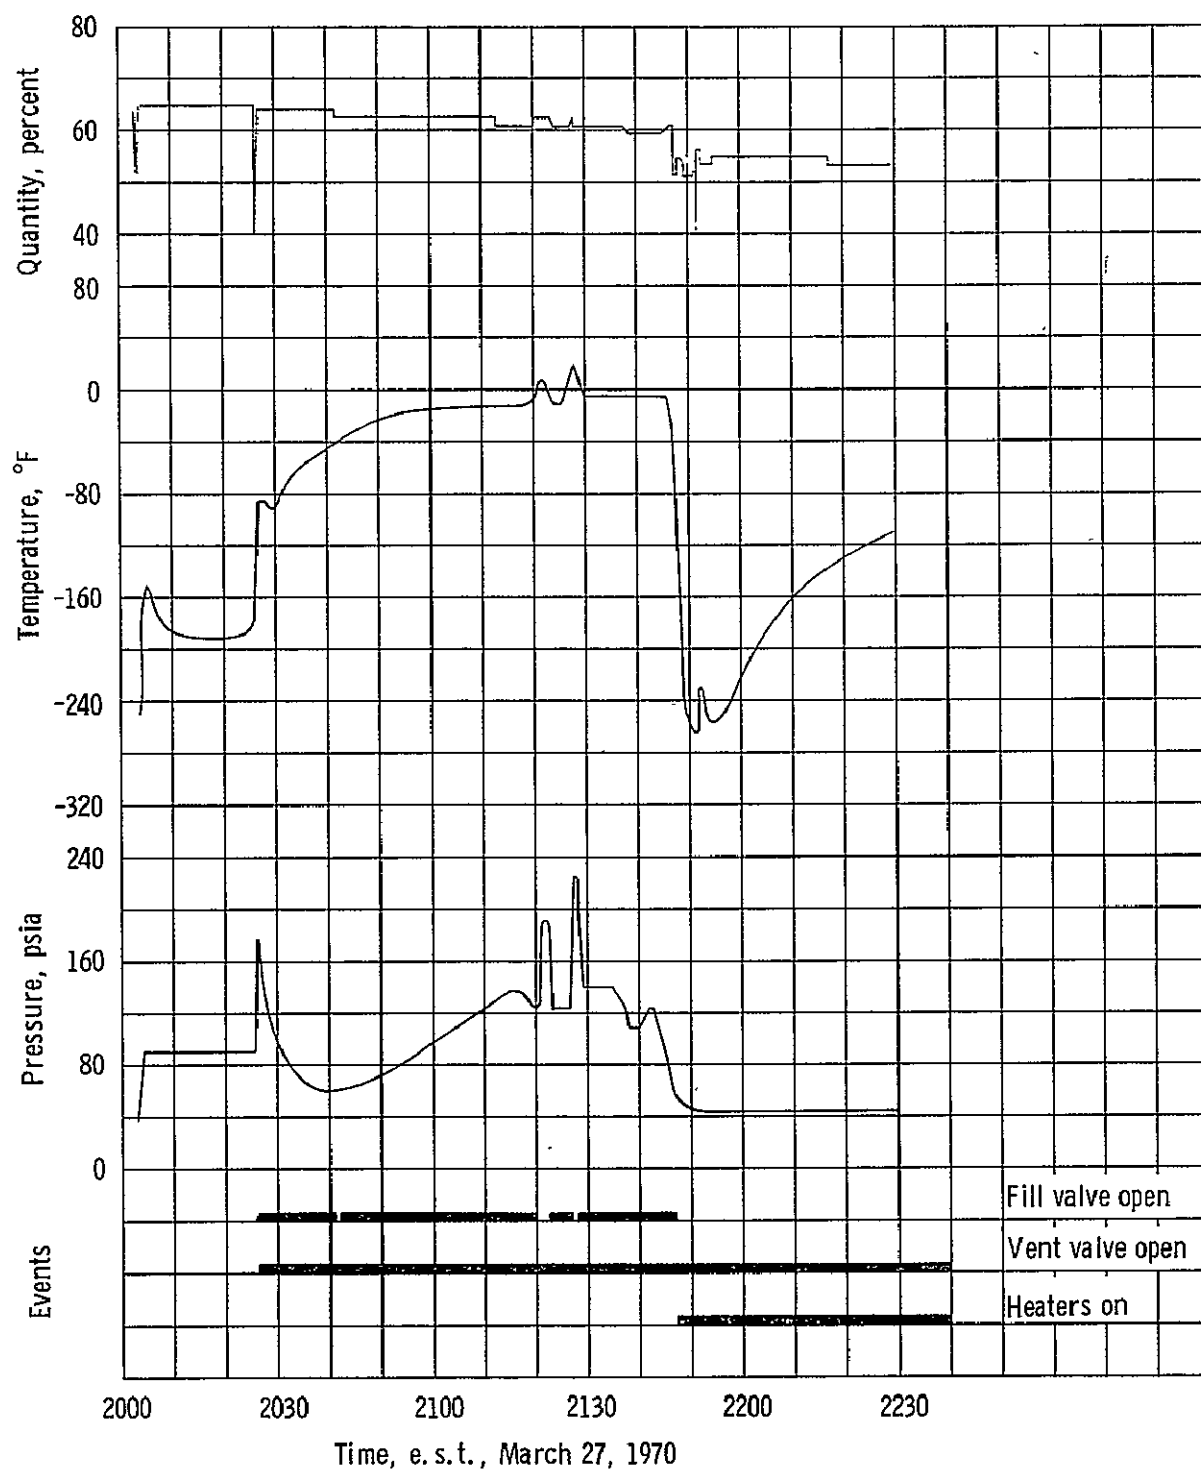
Figure 3-9. - Characteristics of oxygen tank 2 detanking using GSE pressure (CDDT).

First, the GSE regulator controlling the vent line pressure was adjusted to its detanking set point. Pressure in tank no. 2, at approximately 36 psia, increased to 90 psia (fig. 3-9) due to back flow through OV2, while tank no. 1 with 250 psia left over from CDDT remained stable. At 20:25:42 OF1 and OF2 were opened. Tank no. 1 began to empty while tank no. 2 received the inflow from the higher manifold pressure. Twenty seconds later OV1 and OV2 were opened and both tanks equalized while tank no. 1 continued dumping. Seven minutes later, tank no. 1 was empty and an 8 minute GOX purge was begun. Blowing through both tanks, the vent line pressure stabilized at 75 psia.

At 20:41 valves to tank no. 1 were closed and a purge was begun on tank no. 2. Fourteen minutes later the inlet pressure was adjusted upward to 97 psia. Eleven minutes later the inlet pressure was again adjusted upward to approximately 120 psia. By 21:17 after a total of 36 minutes of purging, the quantity had only decreased from 65% to 61%, and it was obvious that something else would have to be tried.

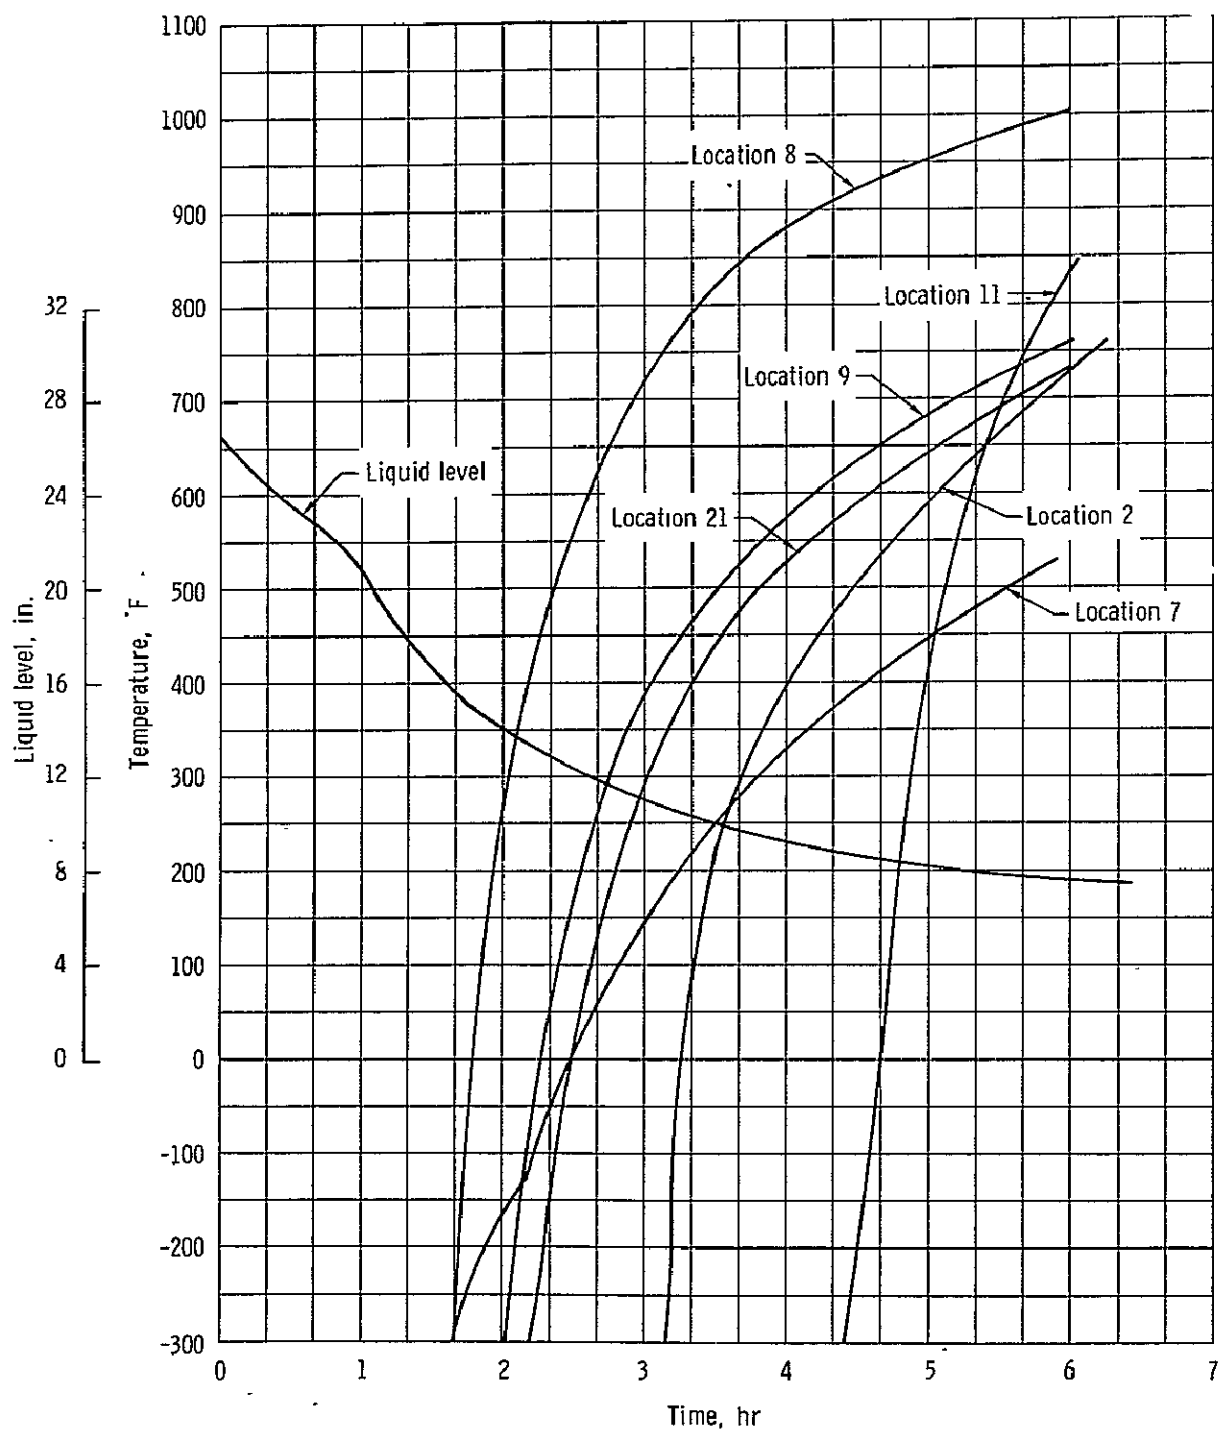
Figure 3-14. - Heater/fan typical test results.

MSC Heater Boil-off Testing.— A spacecraft fan/heater probe (no thermal switches) instrumented with 13 thermocouples, was placed in a full tank of liquid nitrogen (same approximate size as a flight tank). Liquid was then boiled off at ambient pressure by running the fans and heaters continuously. After six hours (fig. 3-14) with the fluid level still two inches above the lower fan, the surface temperature of the uppermost heater coil had stabilized at 1000° F. Directly behind this element, in the inside of the probe, the lower fan wiring is routed through a thin stainless steel conduit touching the .020 inch heater probe wall. All fans and heaters continued to operate for the remaining four hours of the test, with the fan motor case temperature reaching some 350° F.

Post-test disassembly showed that the fan wiring had adhered to the conduit wall (some insulation was torn in its removal); that the insulation had changed composition and was very hard; and that complete circumferential cracking had occurred producing segments of insulation not over 3/4-inch long for a six inch length extending downward from the hottest portion.
